Prevention of Track Buckling and Rail Fracture by Non-destructive Testing of the Neutral Temperature in cw-Rails

Goldschmidt Thermit GmbH, Leipzig, Germany

Dr.-Ing. Alfred Wegner

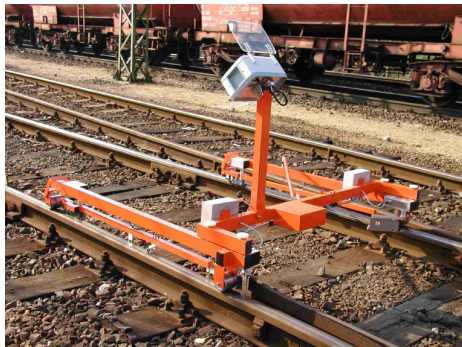
Track geometry

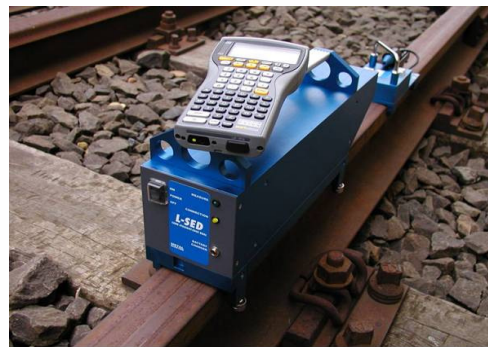
Rail straightness

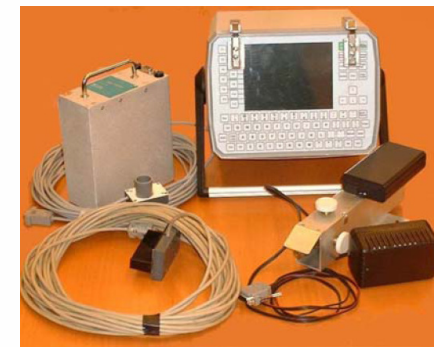
Rail displacements

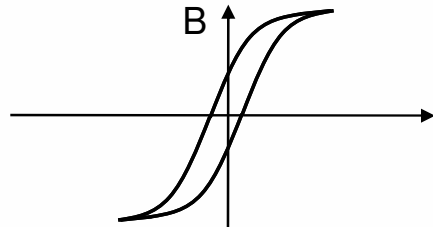
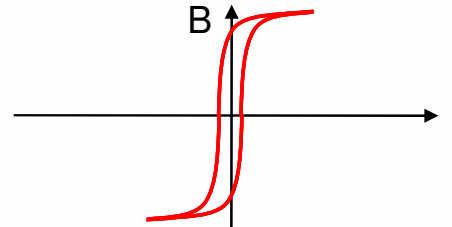
Hysteresis loop:

Permeability increased

Consequence of mechanical stress on the measuring signal

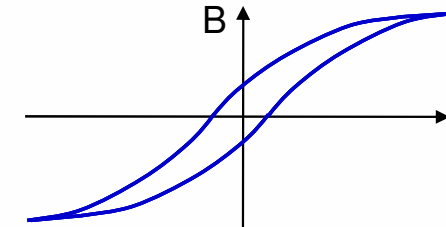
Permeability decreased

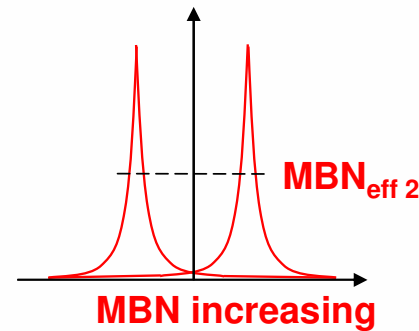
MBN increasing

Villari- effect and Magnetic Barkhausen Noise

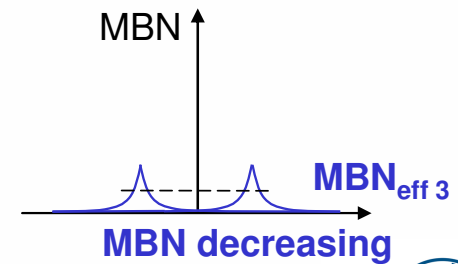
MBN decreasing

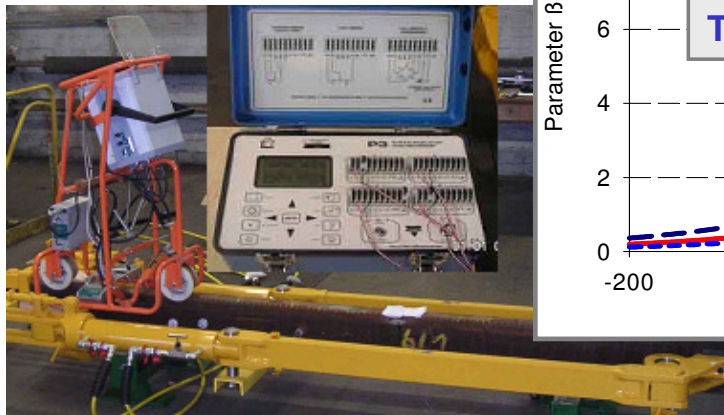
Performance of the calibration

- ✓ Calibration in test rig
- ✓ Measurement at only 1 rail temperature
- ✓ Higher accuracy
- ✓ Exclusion of errors

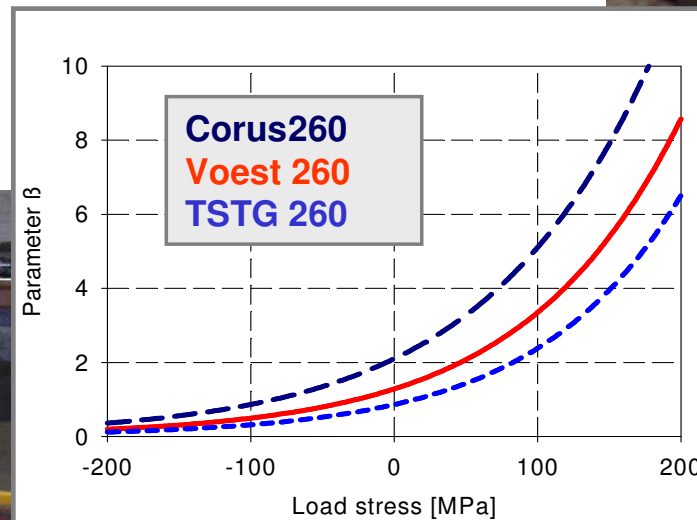
Individual
Calibration curves

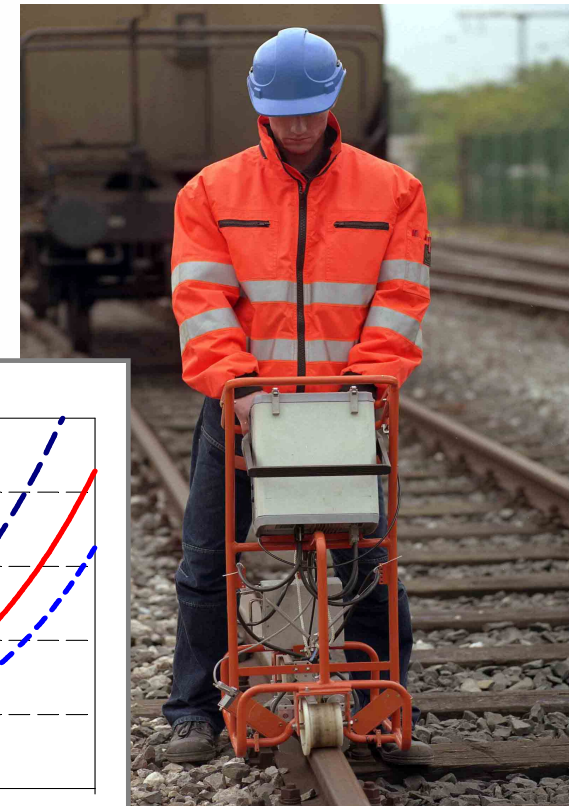
Nd- Measurement
at cw-rail

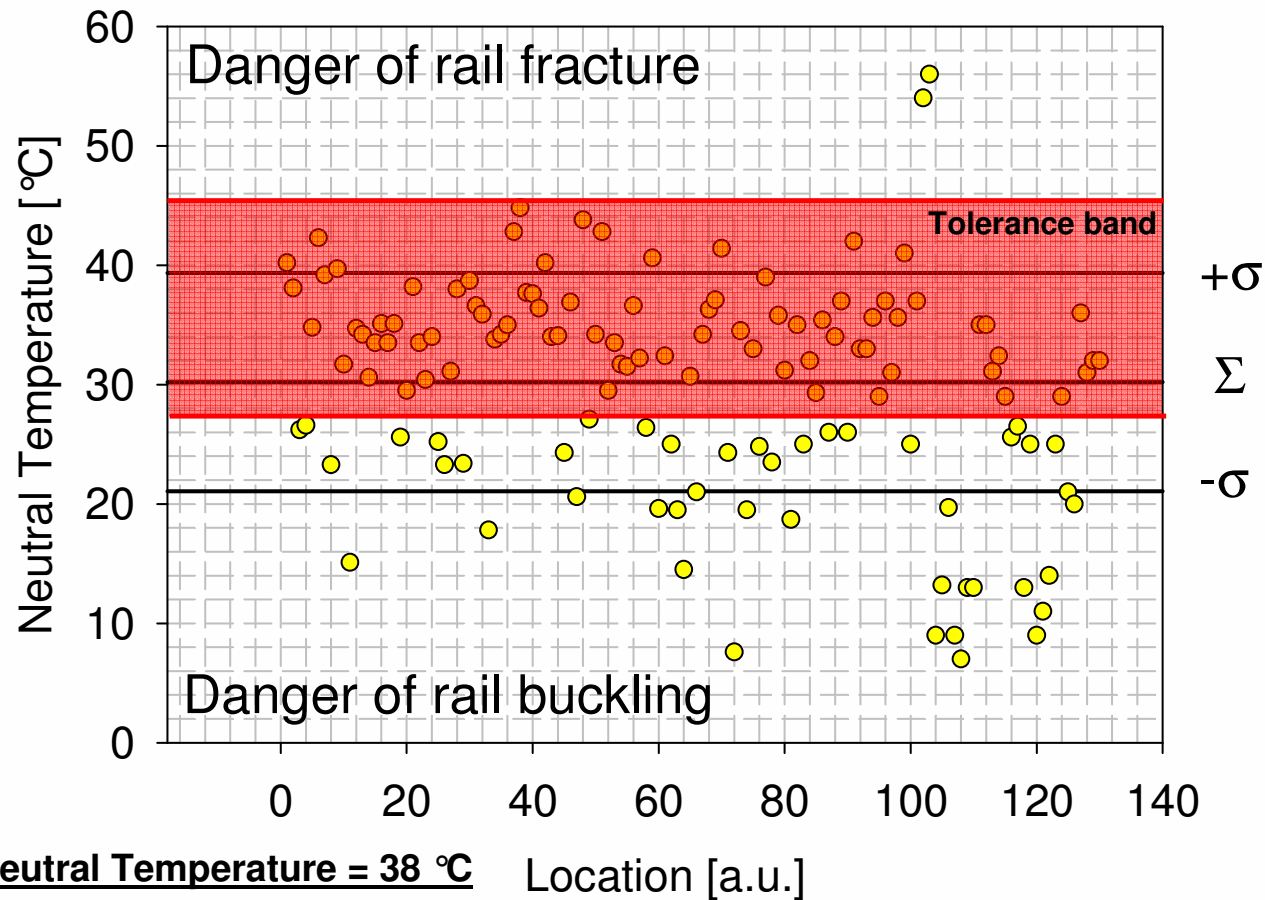
Neutral temperature results ARTC Line Melbourne-Albury

130 Neutral temperature measurements with RailScan

**RailScan SFT inspection measurements -Australia
ARTC Line Melbourne to Albury, March 2006**

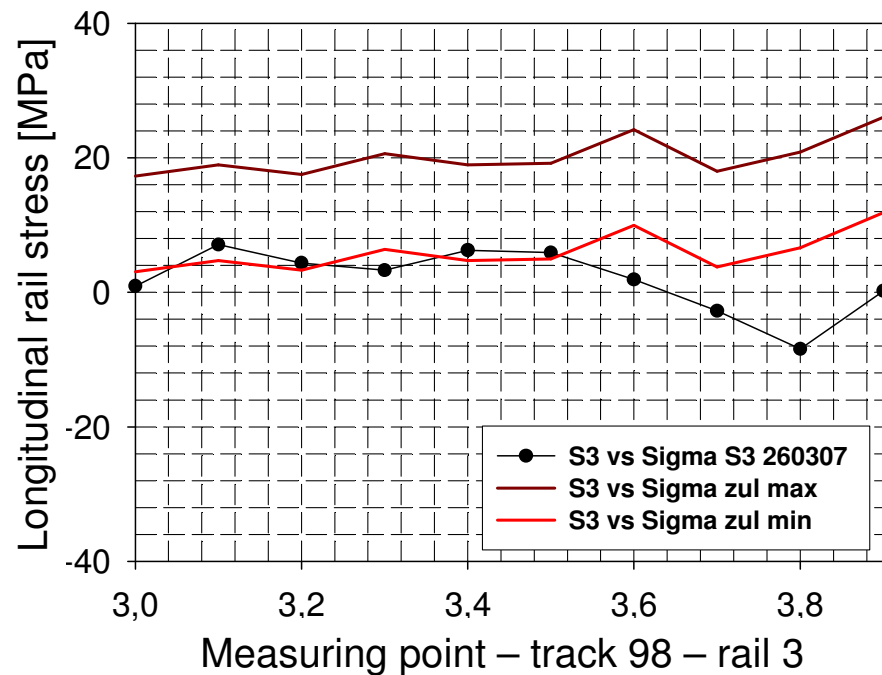
Before restressing

Inspections in Germany - Leipzig

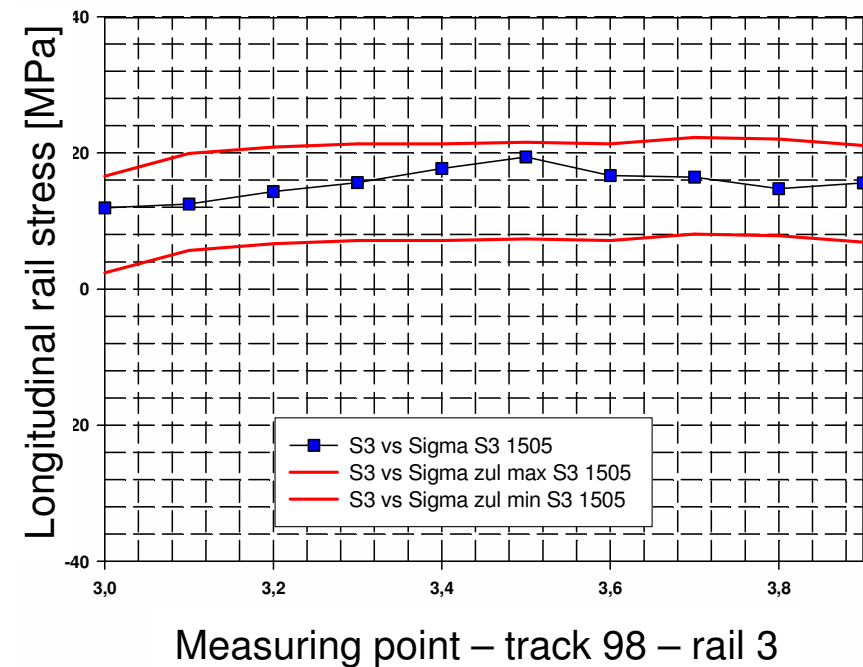
After restressing
